555 Western Ave. Madison, WI

Inspection Date:

09/06/2012

25012-03

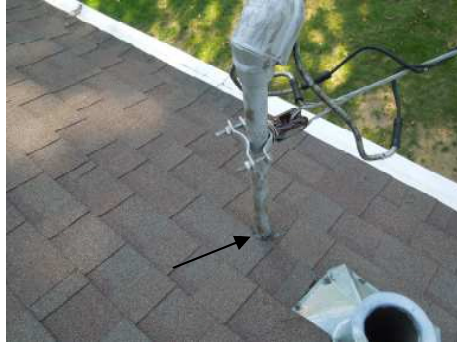
Roof was showing normal wear, but was in overall adequate condition. The plumbing vent at the west side of the roof appears to be partially obstructed. Recommend clearing the vent. There is no flashing installed around the electrical service mast. Recommend monitoring this area.

Flashing not installed at electrical conduit

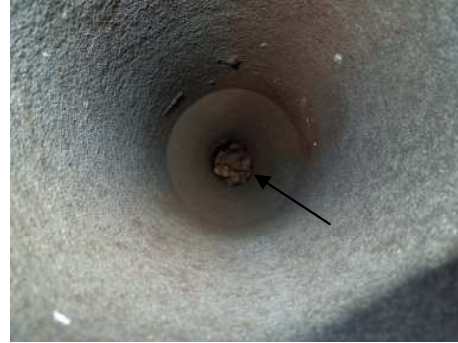
Plumbing vent partially obstructed

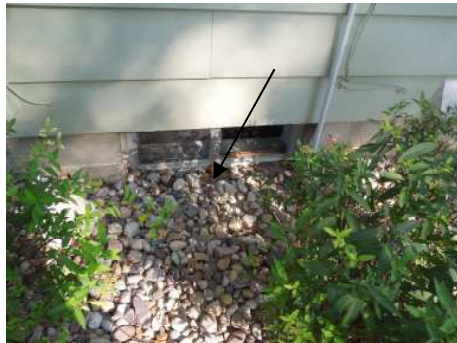
Items which can be found on the exterior of the property including but not limited to play systems, fountains and decorative ornamentations which can be either permanent or free standing are NOT evaluated as part of this home inspection. These types of items can be dangerous for not only children and pets but for adults as well. These types of items should be inspected regularly and extreme care should be exercised. Maintain a positive drainage slope away from the foundation. Negative or flat grade adjacent to the building areas can cause surface water to be directed towards the home. The grade pitches toward the basement windows. Recommend installing window wells and window well covers at the basement windows to direct water away from the area. Also recommend keeping soil excavated several inches below the lower edge of the windows to reduce the chance of water infiltration into the basement area.

Recommend window wells and covers at basement windows

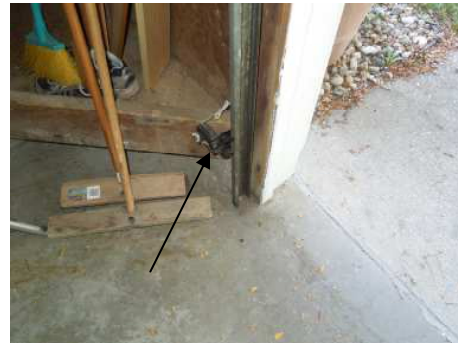
The electric eyes for the door opener are installed higher than generally suggested. Recommend installing the electric eyes at the proper height above the floor. The outlets in the garage are not GFCI protected. Recommend having a licensed electrician install ground fault devices in the garage area. There does not appear to be a proper firewall installed between the garage and the house. Recommend installing a proper firewall.

Electric eyes at overhead door higher than recommended

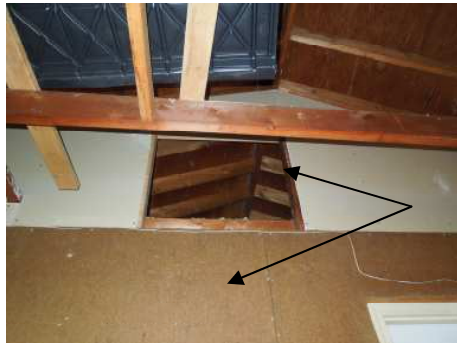
Firewall not installed between house and garage

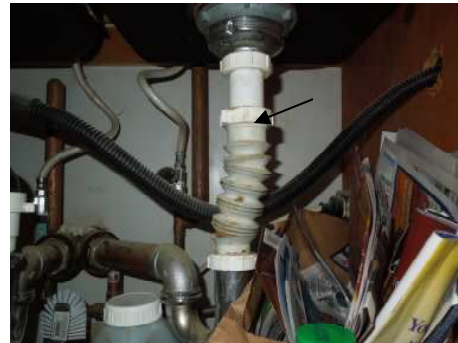
There are flexible drain pipes installed in drain lines under various sinks. This type of piping is not generally recommended and my clog easier than smooth piping. There is a drum trap installed at the drain for the bathtub. Drum traps are more easily clogged than P traps.

Flexible drain piping under various sinks

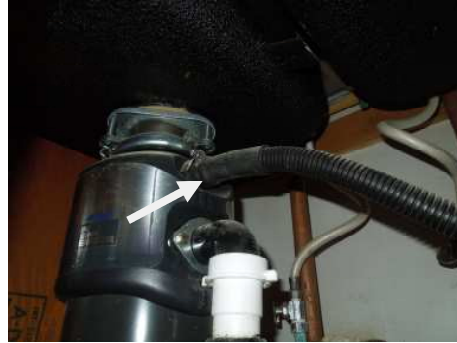
The drain for the dishwasher does not have an air gap present. Recommend having a licensed plumber evaluate and repair as needed. There is flexible drain piping under the kitchen sink. This type of piping is not generally recommended in this area. The kitchen window does not close completely. Recommend having a professional contractor evaluate and repair as needed.

Air gap not installed at dishwasher drain

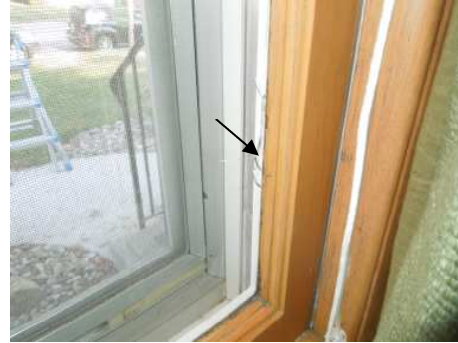
There is a crack in the window glass near the south edge of the window. Recommend having a glass professional evaluate and repair as needed.

Cracking at glass in living room window

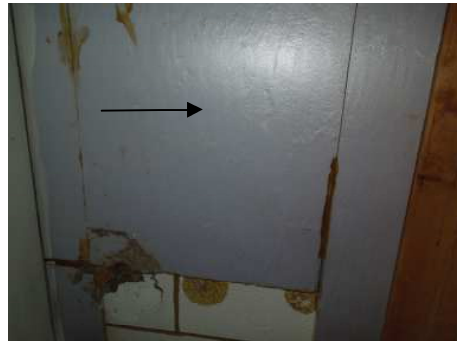
Unprotected foam insulation in basement

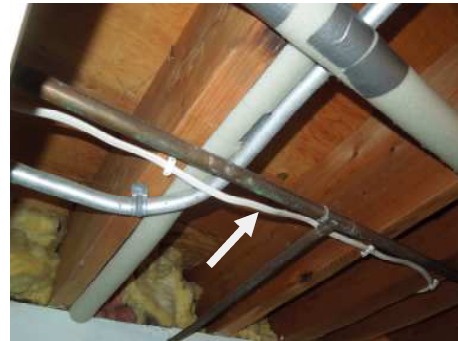
Unprotected romex type wiring in basement

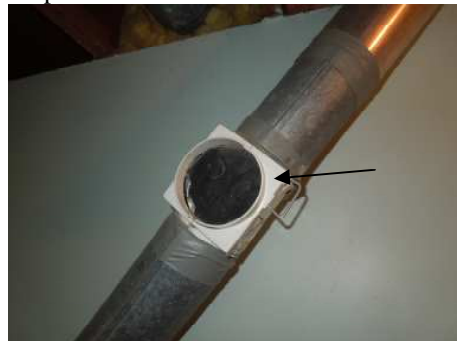
There are outlets near the laundry sink that are not GFCI protected. Recommend having a licensed electrician install ground fault devices as required. Recommend installing a vacuum breaker at the laundry sink faucet. Recommend removing the heat recovery device from the dryer vent.

Recommend removing device at dryer vent

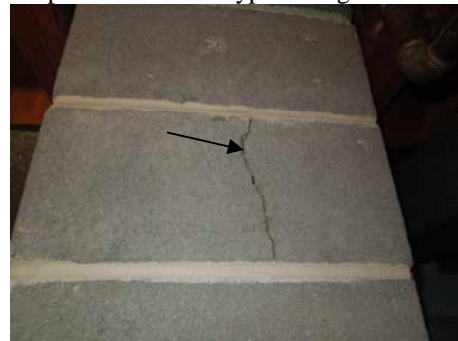
Recommend sealing crack in chimney in basement

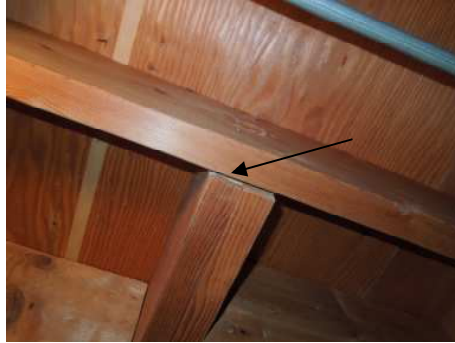
Joist hangers not installed in all recommended areas at basement framing

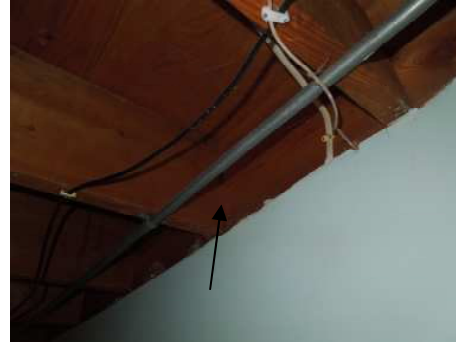
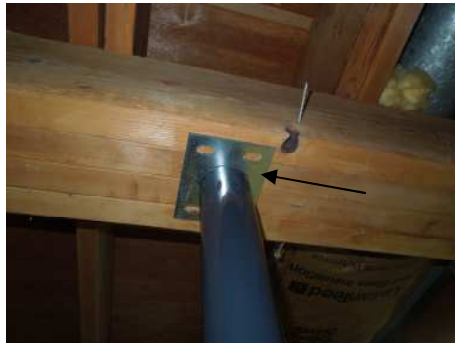
Most of the foundation and the basement framing are covered and not visible for a complete evaluation. Seller reports that there has been past water infiltration in the NE corner of the basement. There is no visual elevated moisture in the basement area at the time of the inspection. Recommend sealing a crack in the block at the chimney in the basement area. There is unprotected romex type wiring at the ceiling. In the cabinet in the NE corner of the family room, there is unprotected foam insulation. This is recommended to be covered by material such as drywall. The main beam is constructed of 2x8 framing material. This may be slightly undersized for the span between columns and has allowed the beam to deflect slightly downward. The steel column at the south end of the basement is not secured to the floor and the beam above.

Support column not permanently secured

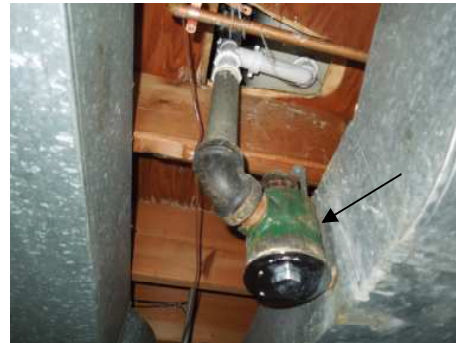
Drum trap at tub/P traps recommended

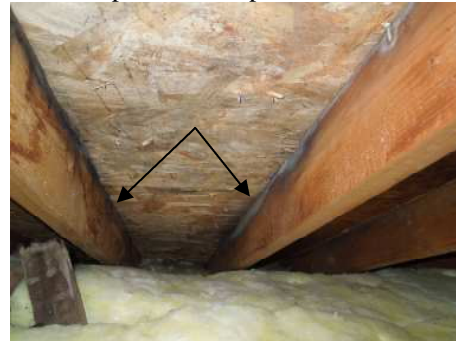
Air gap not installed at dishwasher drain. Bath vent does not appear to be vented to the exterior. Dark staining at the roof framing and sheathing in the attic area which may contain microbial growth. Insufficient lower ventilation at the attic area.

Dark staining at roof framing

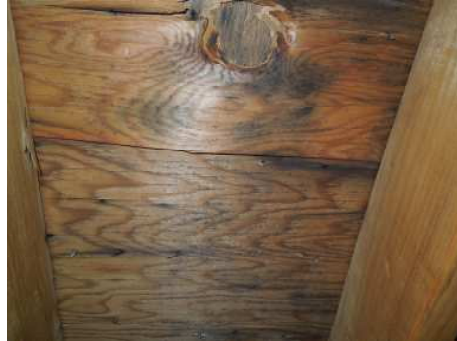
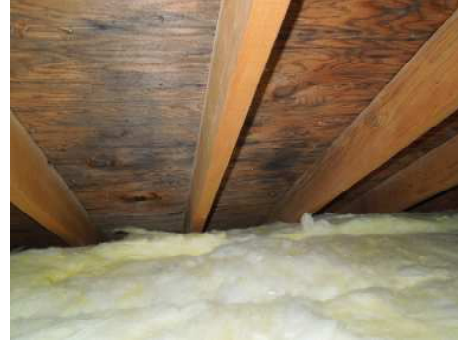
Dark staining at roof sheathing in attic area
